# Manhole Inspection Summary

Manhole # S06AA2012MH

**Location** Address: **3740 CLARINTH AVE**

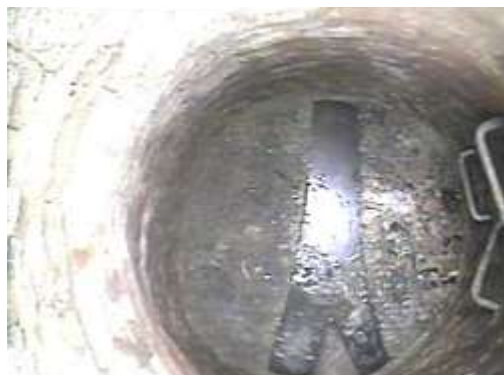
Top View

Adjustment deterioration, loose brick and infiltration. Corbel and Barrel infiltration. Evidence of surcharge - Bench debris.

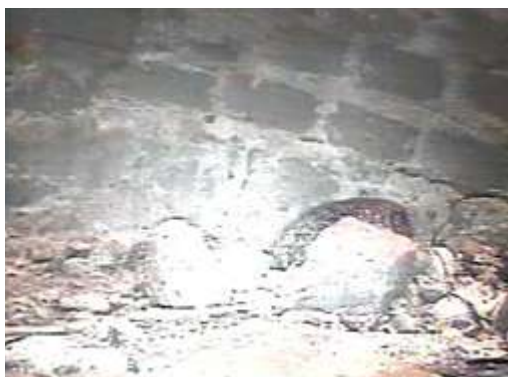
Defect

Bench debris.

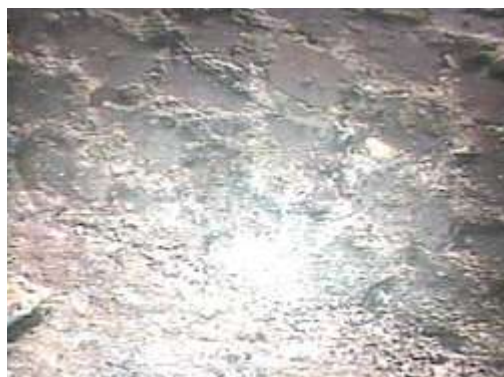
Defect

Barrel deterioration and infiltration.

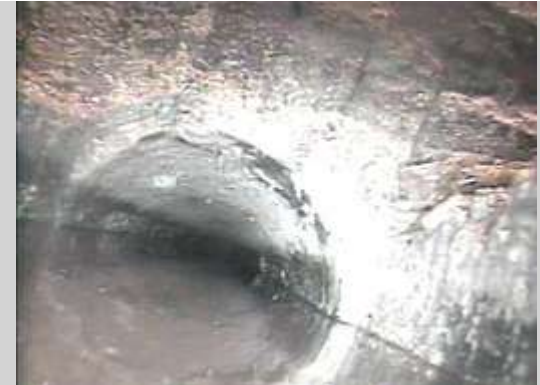
### 8 in. Circular Gravity Sewer Pipe Out @ 12 O'Clock

Deposits: ☐ None ☐ Mud ☐ Sludge ☐ Debris ☒ **Grease**

Silt Depth: **0** (in.) Deposits Extent: **Light**

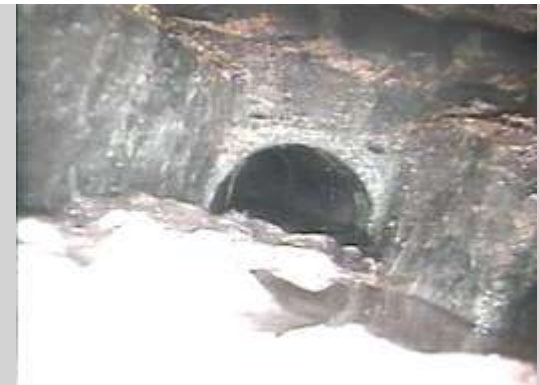
### 6 in. Circular Gravity Sewer Pipe In @ 5 O'Clock

Deposits: ☐ None ☒ **Mud** ☐ Sludge ☒ **Debris** ☐ **Grease**

Silt Depth: **0** (in.) Deposits Extent: **Light**

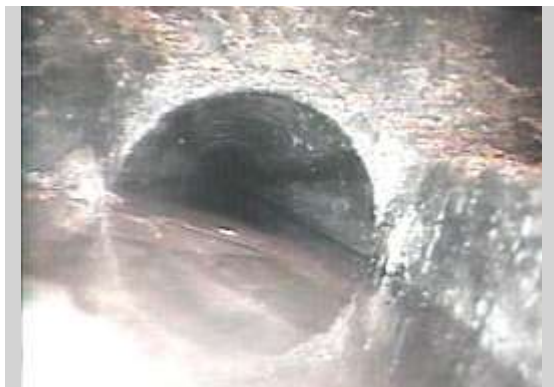
Pipe In @ 6 O'Clock

Deposits: ☐ None ☐ Mud ☐ Sludge ☐ Debris ☒ **Grease**

Infiltration: **Evidence**

Pipe Seal Cond: **Cracked**
